# HELENDALE FAULT

Figure 4 to FEA-176. Air photo interpretations and field observations of young-looking fault features along the Helendale fault. Base map, and fault traces and annotations shown in black are from Morton and others (1980, sheet 1). Fault traces shown in green, and annotations bordered in green are by Manson, with assistance by Hart and Bryant (this report). Additional traces near Cougar Butte, in orange or red, are from Hollenbaugh (1968) or Sadler (1982), respectively.

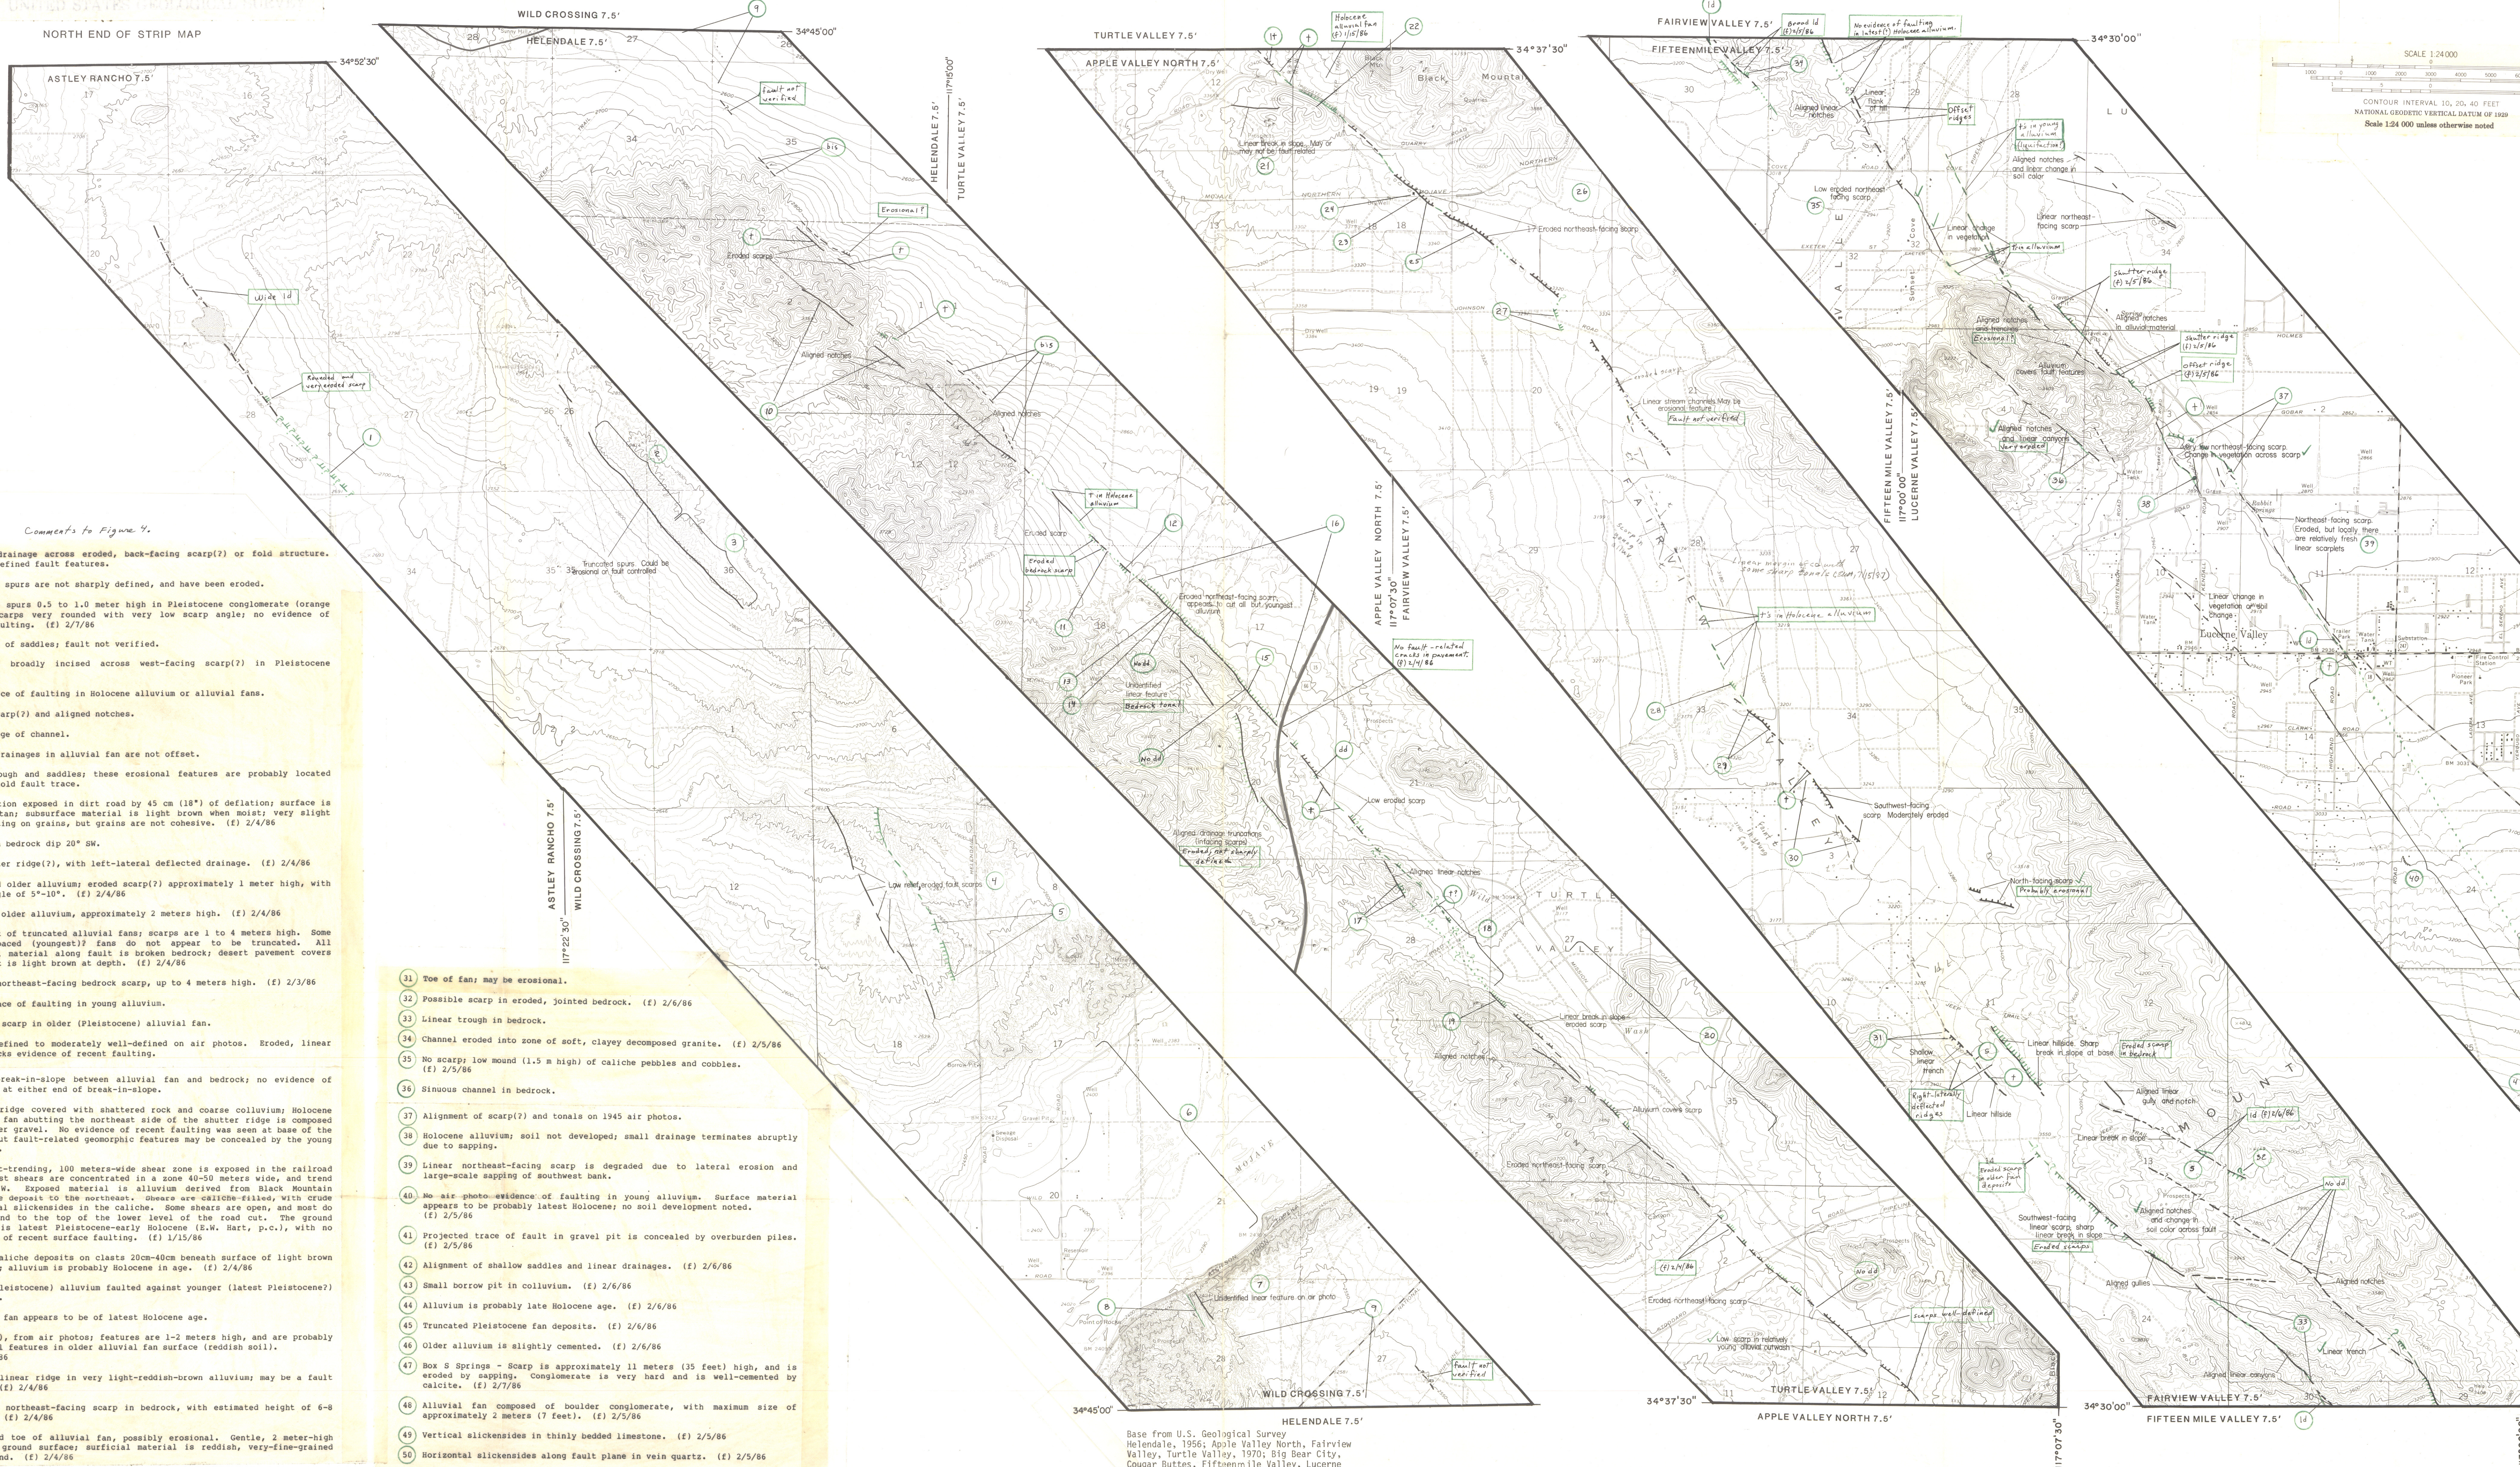
Comments to Figure 4.

- 1 Incised drainage across eroded, back-facing scarp(?) or fold structure. No well-defined fault features.
- 2 "Faceted" spurs are not sharply defined, and have been eroded.

- 3 Truncated spurs 0.5 to 1.0 meter high in Pleistocene conglomerate (orange soil); scarps very rounded with very low scarp angle; no evidence of active faulting. (f) 2/7/86

- 4 Alignment of saddles; fault not verified.
- 5 Drainages broadly incised across west-facing scarp(?) in Pleistocene alluvium.
- 6 No evidence of faulting in Holocene alluvium or alluvial fans.

- 7 Eroded scarp(?) and aligned notches.
- 8 Linear edge of channel.
- 9 Incised drainages in alluvial fan are not offset.
- 10 Broad trough and saddles; these erosional features are probably located along an old fault trace.

- 11 Soil section exposed in dirt road by 45 cm (18") of deflation; surface is pink to tan; subsurface material is light brown when moist; very slight clay coating on grains, but grains are not cohesive. (f) 2/4/86

- 12 Shears in bedrock dip 20° SW.
- 13 Low shutter ridge(?) with left-lateral deflected drainage. (f) 2/4/86
- 14 Truncated older alluvium; eroded scarp(?) approximately 1 meter high, with scarp angle of 5°-10°. (f) 2/4/86

- 15 Scarp in older alluvium, approximately 2 meters high. (f) 2/4/86
- 16 Alignment of truncated alluvial fans; scarps are 1 to 4 meters high. Some widely-spaced (youngest?) fans do not appear to be truncated. All surficial material along fault is broken bedrock; desert pavement covers soil that is light brown at depth. (f) 2/4/86

- 17 Eroded, northeast-facing bedrock scarp, up to 4 meters high. (f) 2/3/86
- 18 No evidence of faulting in young alluvium.
- 19 Possible scarp in older (Pleistocene) alluvial fan.

- 20 Poorly defined to moderately well-defined on air photos. Eroded, linear scarp lacks evidence of recent faulting.
- 21 Linear break-in-slope between alluvial fan and bedrock; no evidence of faulting at either end of break-in-slope.

- 22 Shutter ridge covered with shattered rock and coarse colluvium; Holocene alluvial fan abutting the northeast side of the shutter ridge is composed of boulder gravel. No evidence of recent faulting was seen at base of the ridge, but fault-related geomorphic features may be concealed by the young alluvium.

- 23 Northwest-trending, 100 meters-wide shear zone is exposed in the railroad cut. Most shears are concentrated in a zone 40-50 meters wide, and trend N. 45° W. Exposed material is alluvium derived from Black Mountain limestone deposits to the northeast. Shears are calciche-filled, with crude horizontal slickensides in the calciche. Some shears are open, and most do not extend to the top of the lower level of the road cut. The ground surface is latest Pleistocene-early Holocene (B.W. Hart, p.c.), with no evidence of recent surface faulting. (f) 1/15/86

- 24 Slight calciche deposits on clasts 20cm-40cm beneath surface of light brown alluvium; alluvium is probably Holocene in age. (f) 2/4/86
- 25 Older (Pleistocene) alluvium faulted against younger (latest Pleistocene?) alluvium.

- 26 Alluvial fan appears to be of latest Holocene age.
- 27 Scarps(?) from air photos; features are 1-2 meters high, and are probably erosional features in older alluvial fan surface (reddish soil). (f) 2/4/86

- 28 Eroded, linear ridge in very light-reddish-brown alluvium; may be a fault scarp. (f) 2/4/86
- 29 Possible northeast-facing scarp in bedrock, with estimated height of 6-8 meters. (f) 2/4/86

- 30 Truncated toe of alluvial fan, possibly erosional. Gentle, 2 meter-high rise of ground surface; surficial material is reddish, very-fine-grained silty sand. (f) 2/4/86

- 31 Toe of fan; may be erosional.
- 32 Possible scarp in eroded, jointed bedrock. (f) 2/6/86
- 33 Linear trough in bedrock.
- 34 Channel eroded into zone of soft, clayey decomposed granite. (f) 2/5/86

- 35 No scarp; low mound (1.5 m high) of caliche pebbles and cobbles. (f) 2/5/86
- 36 Sinuous channel in bedrock.
- 37 Alignment of scarp(?) and tonals on 1945 air photos.

- 38 Holocene alluvium; soil not developed; small drainage terminates abruptly due to sapping.
- 39 Linear northeast-facing scarp is degraded due to lateral erosion and large-scale sapping of southwest bank.

- 40 No air photo evidence of faulting in young alluvium. Surface material appears to be probably latest Holocene; no soil development noted. (f) 2/5/86

- 41 Projected trace of fault in gravel pit is concealed by overburden piles. (f) 2/5/86
- 42 Alignment of shallow saddles and linear drainages. (f) 2/6/86

- 43 Small borrow pit in colluvium. (f) 2/6/86
- 44 Alluvium is probably late Holocene age. (f) 2/6/86
- 45 Truncated Pleistocene fan deposits. (f) 2/6/86

- 46 Older alluvium is slightly cemented. (f) 2/6/86
- 47 Box S Springs - Scarp is approximately 11 meters (35 feet) high, and is eroded by sapping. Conglomerate is very hard and is well-cemented by calciche. (f) 2/7/86

- 48 Possible northeast-facing scarp in bedrock, with estimated height of 6-8 meters. (f) 2/4/86
- 49 Vertical slickensides in thinly bedded limestone. (f) 2/5/86

- 50 Horizontal slickensides along fault plane in vein quartz. (f) 2/5/86
